THE 16TH EDITION OF THE INTERNATIONAL CONFERENCE
EUROPEAN INTEGRATION
REALITIES AND PERSPECTIVES**Analyzing Surface Roughness of an
Auto-Truck Cylinder After Several Running Hours****Daniela Voicu¹, Ramona-Monica Stoica², Radu Vilău³**

Abstract: Present paper aims to present the measuring process and results regarding roughness of the inner surface of a truck cylinder, according to standard (STAS 6635-87). To that purpose, it was used a Surtronic S-Series roughness tester, with a stylus able to measure within the range 400 μm . According to the before-mentioned standard, there were performed 4 measurements on the same circular line, each one shifted by 90 degrees to the previous. The process was repeated on eight functional areas characteristic to the cylinder (entire length was divided into eight equal parts). With the use of measured values, it was possible to analyze whether the cylinder's inner surface had proper roughness according to specific standards, even after several functioning cycles.

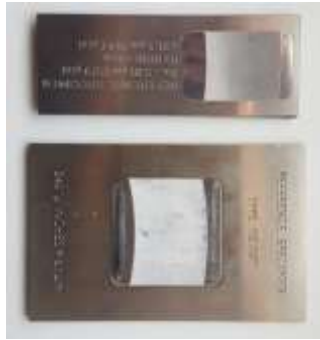
Figure 1. Standard Sample

In order to verify the proper functioning of the tester, it was used a standard sample of 5.81 μm , Figure 1 provided by the manufacturer.

Following the first measurement, used to calibrate the tester, it was obtained a measuring error of 3% which was eliminated by two means: by selecting a different filter and by modifying the stylus position so that its longitudinal axis is parallel to the tested surface. The initial filter selected was type 2CR, (SR EN ISO 4287:2003) with Gaussian filter (among its properties, it can be mentioned the capacity to consider data, before and after defining the position of stylus, when calculating average line. The cut-off value (UPR) is determined by distribution width of Gauss curve. The effect, for selected filter value, is 50% of maximum bandwidth. Gaussian filter eliminates half of first cut-off of the analyzed profile, and half of the last cut-off) (Mitutoyo, 2016).

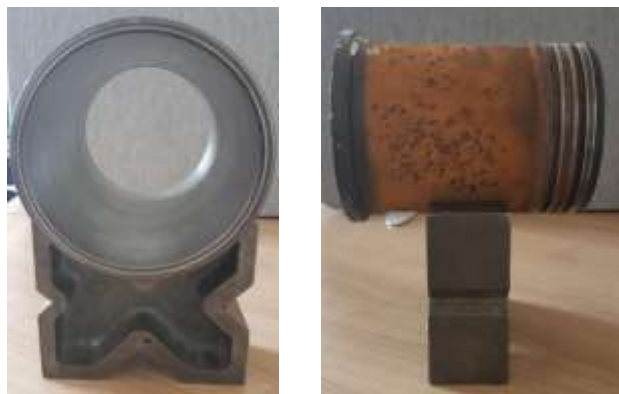
Figure 3. The Analyzed Cylinder

In Figure 3 it is presented the analyzed cylinder which was placed on a special prismatic surface to ensure a horizontal position.

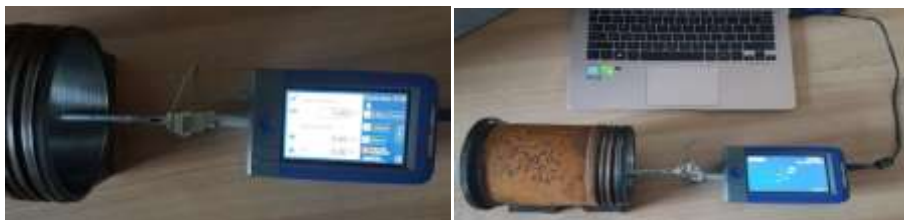
Figure 4. The Connection between Roughness Tester and Laptop

In Figure 4, it is presented the disposal manner of stylus on cylinder bore, as well as the connection between roughness tester and laptop.

Measured data were stored and subsequently processed due to the tester software, named TalyProfile, which was installed on the laptop (Murashov, 2020).

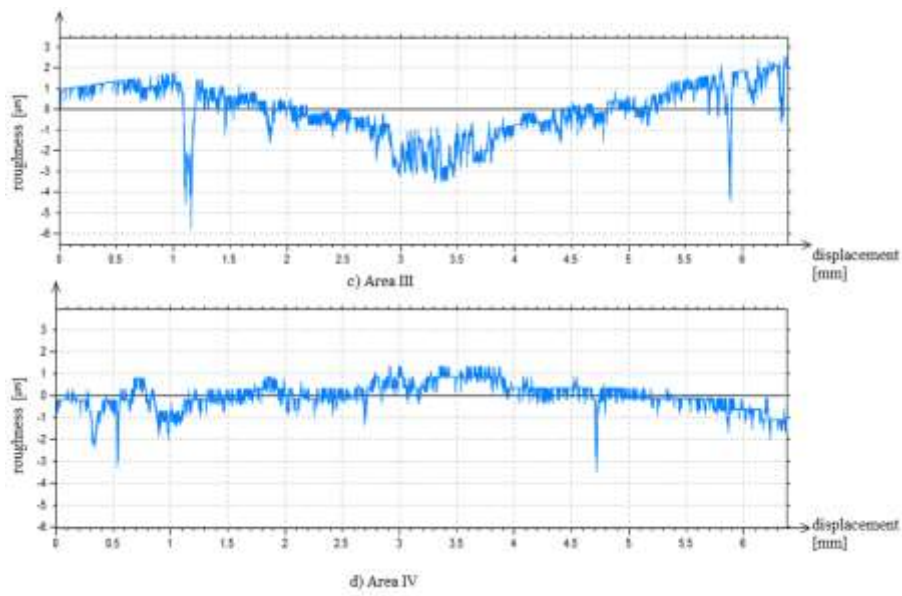
Figure 5. Results of Measurements for Areas I-IV, Section A-A of Cylinder

For example, in Figure 5 and Figure 6 there are presented results of measurements for all 8 areas, corresponding to section A-A. This means that the first graph contains values of surface roughness in case of area I, section A-A; the second graph is specific to area II, section A-A, and so forth that the eighth graph presents roughness values of cylinder liner in case of area VIII, section A-A. The stylus displacement on cylindrical surface was set to 6 mm. All figures are disposed in order, starting from cylinder head, where piston rings come in contact with cylinder bore, and down to the bottom of cylinder liner.

The analysis of results depicted in graphs from Figure 5 and Figure 6, as well as from the values comprised in Table 1, highlights that there are few differences between measured values in case of each one of the 8 areas analyzed. Moreover, differences are more visible where piston rings come in contact to cylinder bore, which was expected.
